# MATRIX UPDATE

## USB DRIVE BUG FIX

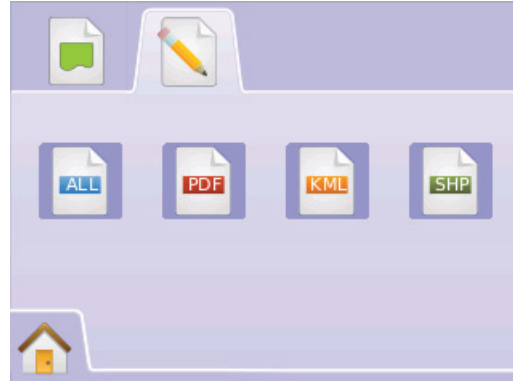
If you do not have a USB Drive inserted into your unit and the Reports icons are enabled your unit has the problem. (Icons are enabled when they are in color and are able to be pressed. An icon that is in grayscale

Figure 1-1: YOU HAVE A PROBLEM IF YOU SEE COLORED ICONS

1. Download the zip file "fix-USBdrive.zip" directly to your computer's Desktop or Downloads folder (see "How to download ZIP files.pdf" for details).
2. Double click the zip file then select either A or B:
  - A) Copy and paste the "tjrun" folder to the root directory of an empty USB drive.
  - B) Using the "Extract all files" function, unzip/uncompress the downloaded file to the root directory of an empty USB drive (see "How to download ZIP files.pdf" for details).

3. Properly eject the USB drive from your computer using the "Safely Remove Hardware" icon from the Task Bar or the "Eject this disk" function from the My Computer window or the "Eject Disk" option (on a MAC).
4. With the console OFF, lift rubber cover and insert the USB drive into the Matrix console.
5. Press the Power Button to turn the console ON.

6. When prompted, remove USB drive from the Matrix console.
7. Press and hold the Power On/Off Button for five (5) seconds to power down the console.
8. Press and release the Power On/Off Button to power-on the console again.
9. Verify your update has installed by going to the Save Information Tab with no USB Drive in the console and check that the report icons are disabled.
  - If the splash screen appears in step 5 and the verification check in step 9 does not pass, re-run the resolution process from step 1.
