**MODEL 66GS62H****East/west faults**

Reference AvW 10 03 2004 - 3

### Changes to the circuit during production

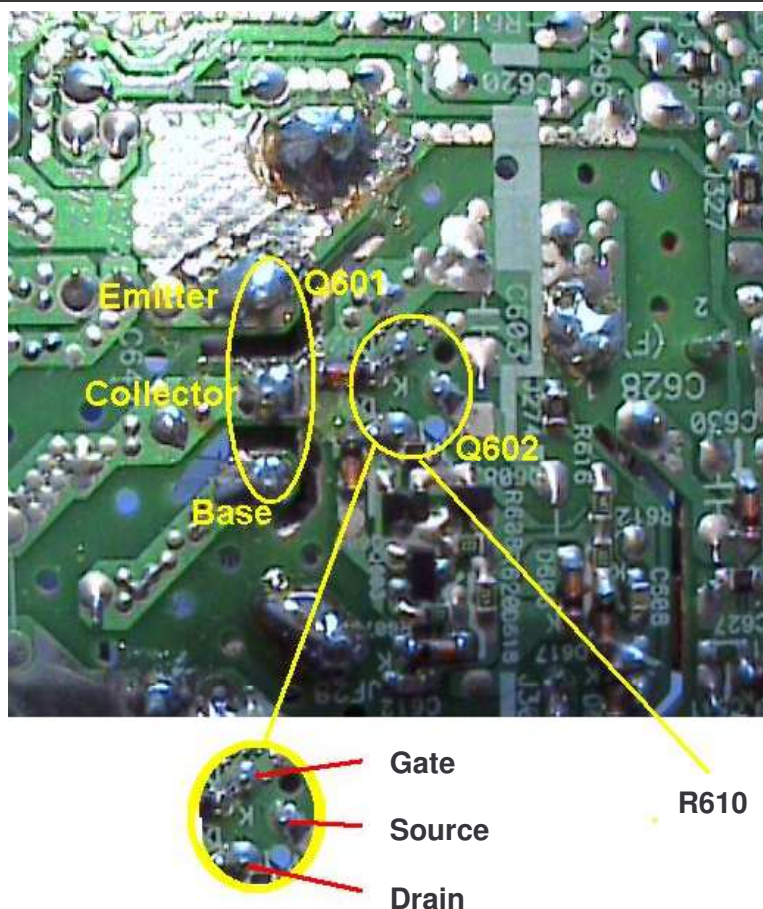
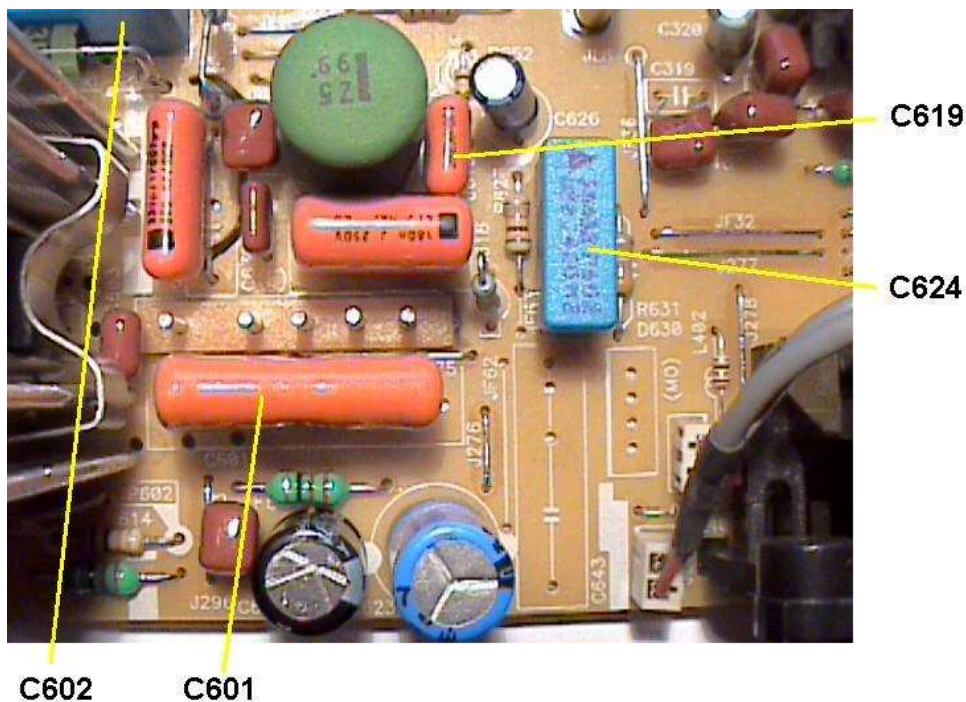
1. A larger heatsink was used for Q601 and Q602 to help reduce the operating temperature of these devices. The original heatsink is 65mm in height; the new one is 110mm in height. If the heatsink has already been changed for the larger type, it is not necessary to change it again. See the picture relating to the new Q602 for new heatsink.
2. Q602 was changed for a more powerful device.
3. The inner pincushion correction transistor, Q610 was up rated from a SMD device to a wire ended type. The new transistor is now mounted on the component side of the PWB. If a set comes into the workshop, and this resistor has not been changed, it is advisable to do so, using the part number for Q610 given below:

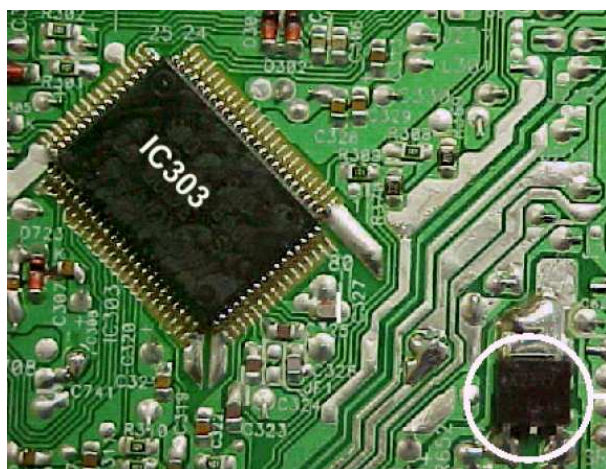
Original Q610 Transistor

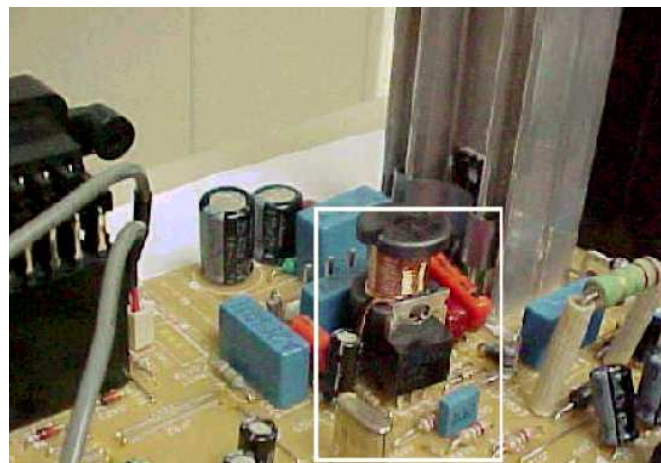
New Q610 Transistor
