SCHEMATIC DIAGRAM

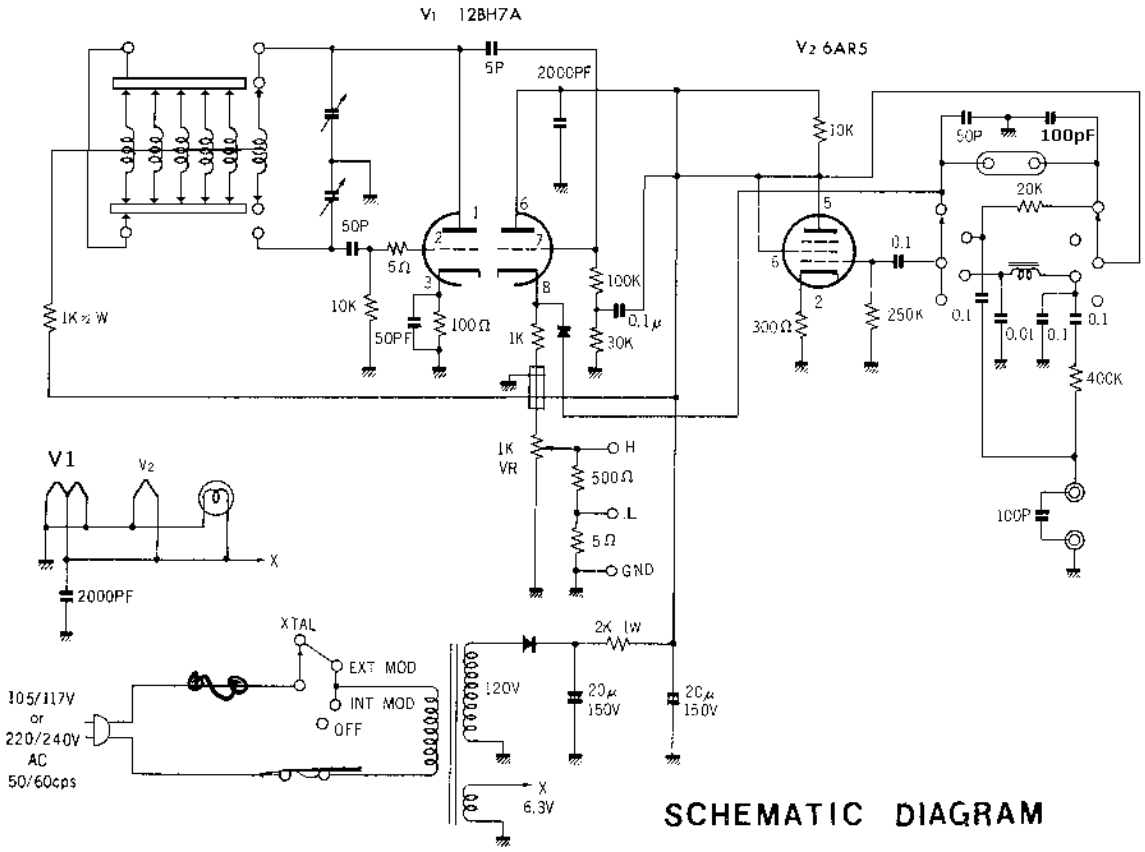
Addendum: **Due to the low voltage used on B+. It has been noted that the 6AR5 is operating on the "knee" of a curve. Producing a distorted modulation pattern.**
